Home Inspection Report

Inspection Address:
1519 Sunshadow Lane
San Jose, CA

Inspection Date:
July 22, 2014

Report Number:
072214-02

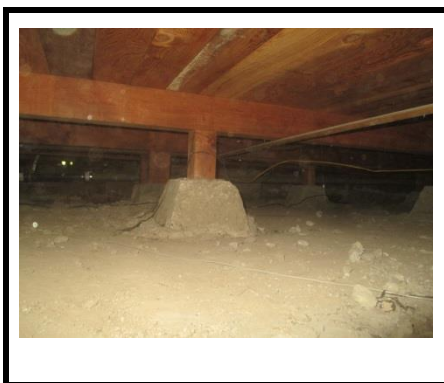
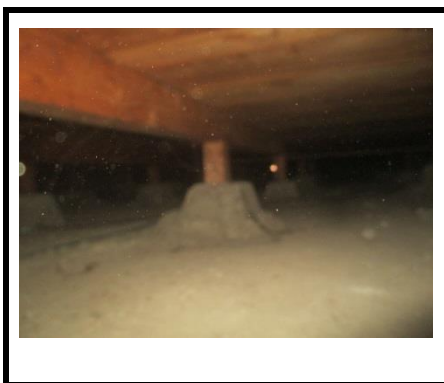
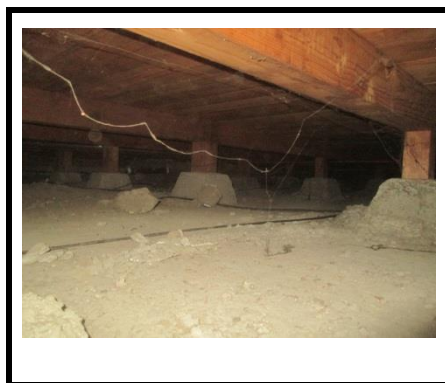
Pictures 1 thru 3... The crawl space soil was dry during this inspection, the flooring supports and sub flooring were in acceptable condition.

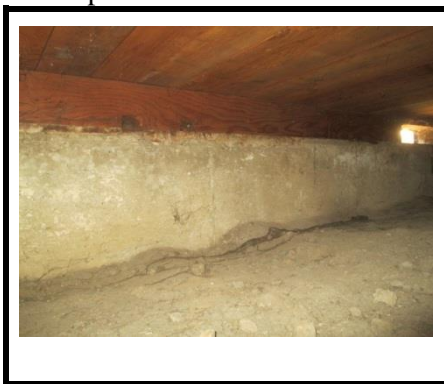
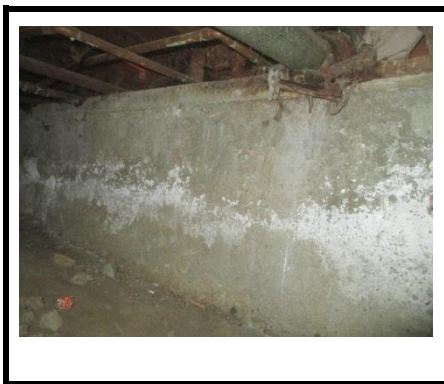
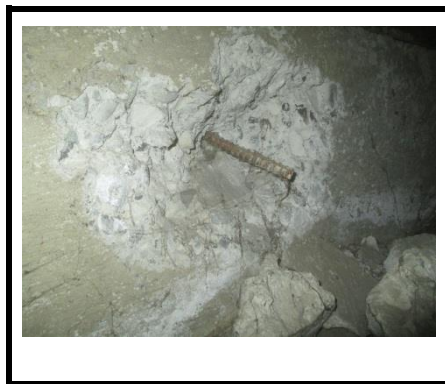
Pictures 1 thru 3... The concrete foundation walls were in acceptable condition with no significant cracks observed however some minor efflorescences observed and one chipped out area under the back slider door ,leaving the steel rebar exposed, the exposed steel rebar should be sealed or coated with anti corrosion mastic.

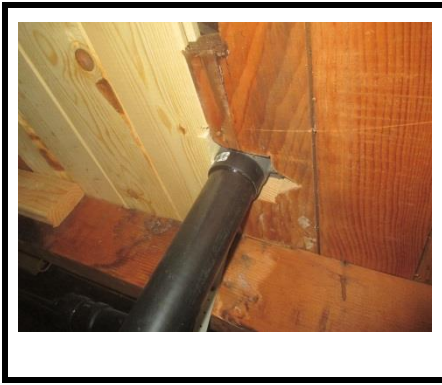
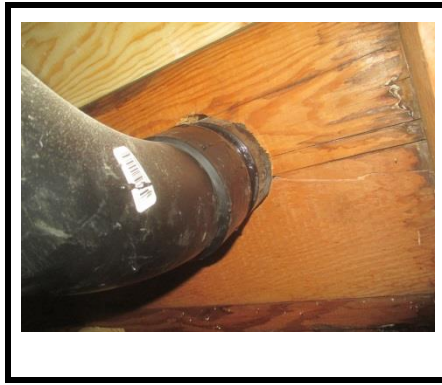
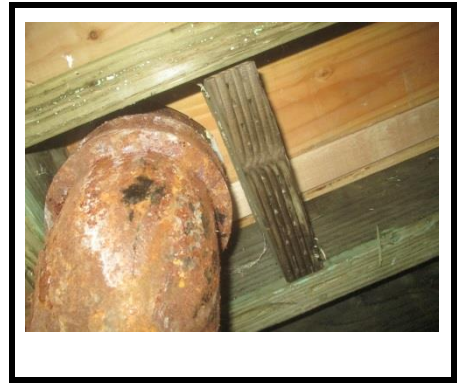
Pictures 1 thru 3... The sub flooring under the master bath shower, toilet and hall bath toilet was in acceptable condition with no leaks or damage observed.

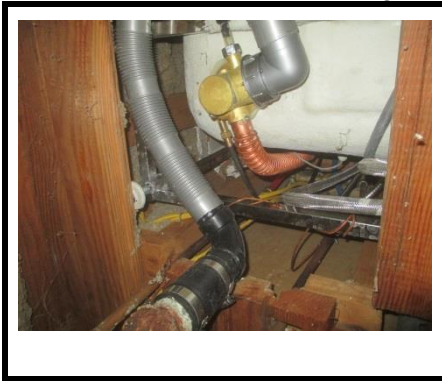
Picture 1... The sub flooring under the hall bath jetted tub was in acceptable condition with no leaks observed.

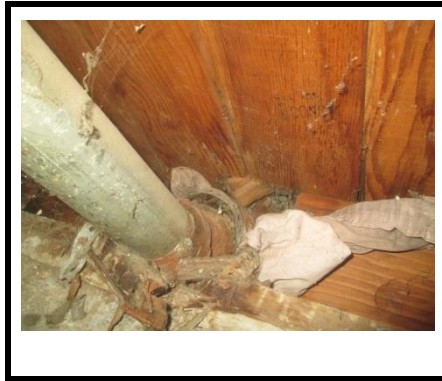
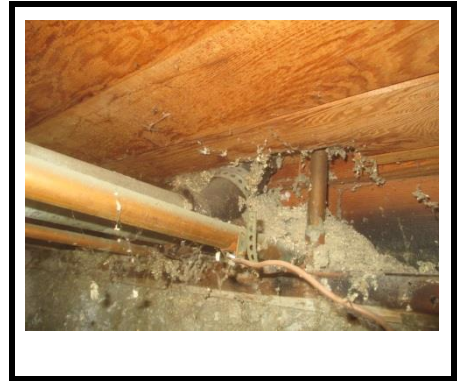
Pictures 2 & 3... The sub flooring under the kitchen and laundry areas was in acceptable condition with no leaks or damage observed.

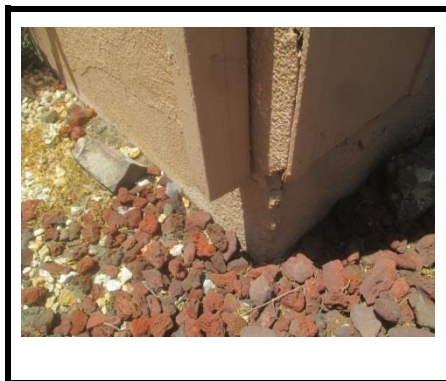
The lower section of the downspout, or elbow, was missing at the left front corner of the house. The missing elbow should be replaced to help direct water away from the foundation.

Picture 1... The gutter downspout at the left front corner of the house is in need of an elbow and splash block.

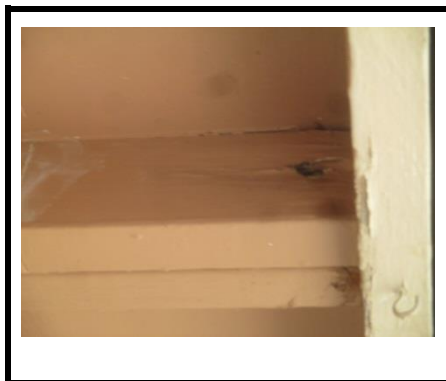
Picture 2... The deteriorated rafter tail end observed at the garage front.

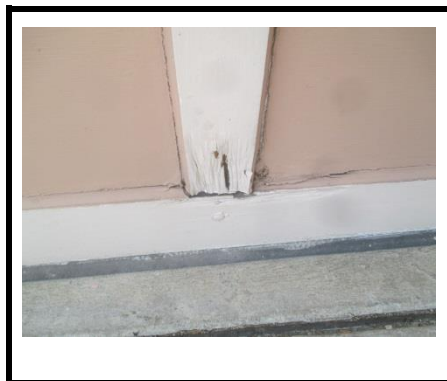
Picture 3... The bottom garage roll up door panel was deteriorated in several areas.

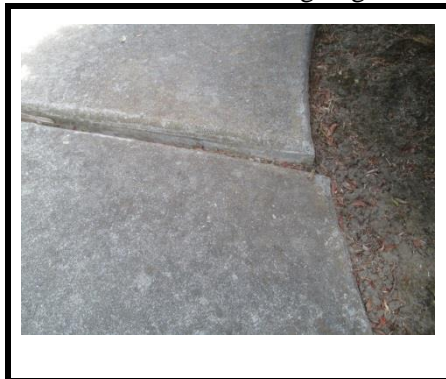
Picture 1... The uplifted section of concrete at the right front corner of the house causes a trip hazard.

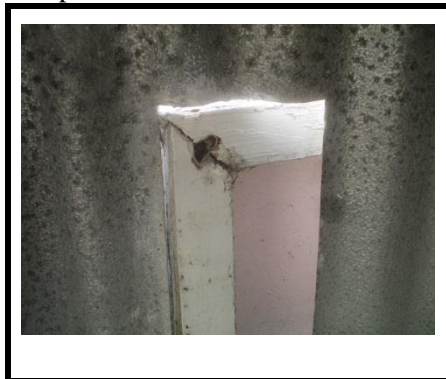
Picture 2... The fascia board corner at the right rear corner of the house was deteriorated and should be repaired.

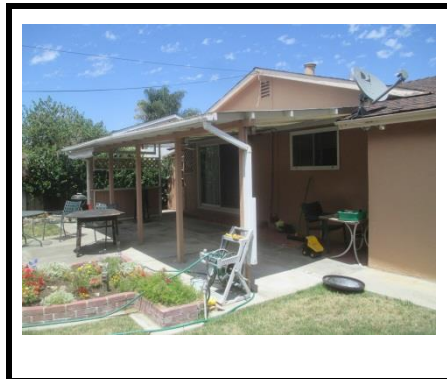
Picture 3... The patio and cover were overall in acceptable condition

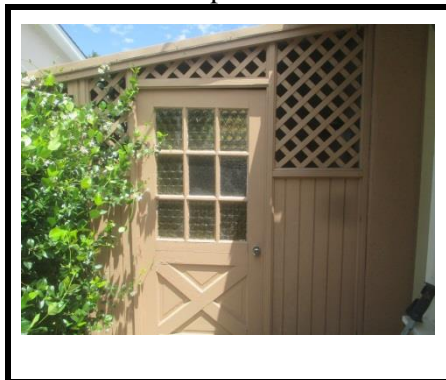
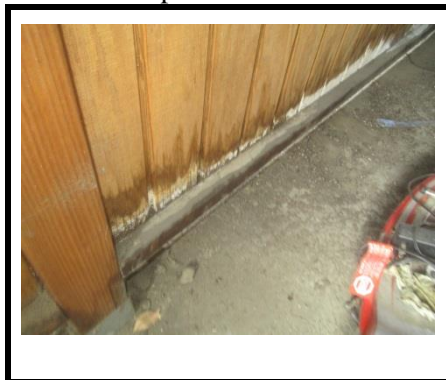
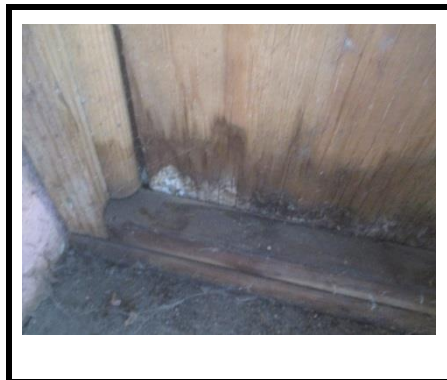
Pictures 1 thru 3... The attached storage shed at the right side of the house had several areas of fungus damage observed.

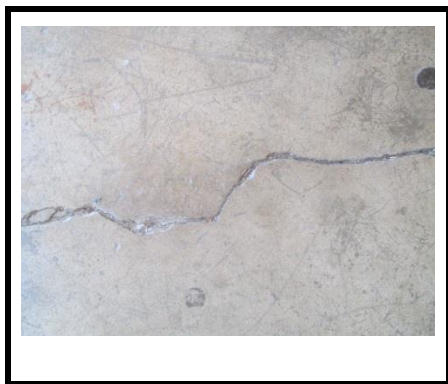
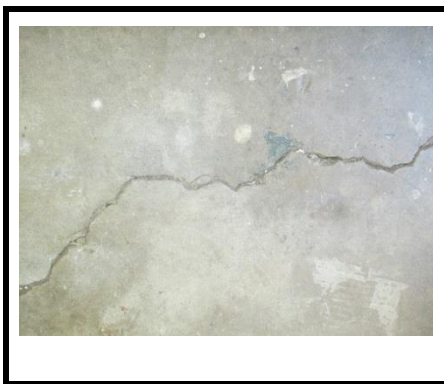
Minor cracking was evident in the floor slab, but no noticeable vertical displacement of the slab was observed. No action is indicated.

Pictures 1 & 2... The small to moderate cracks observed in the garage floor slab.

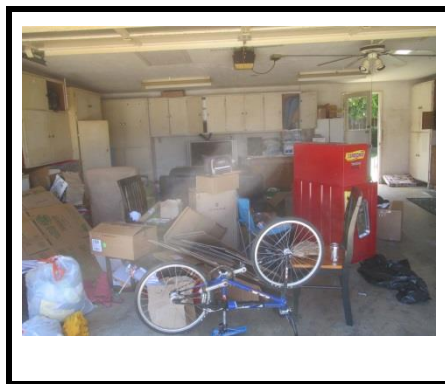
Picture 3... The garage was full of personal stuff and could not be fully viewed.

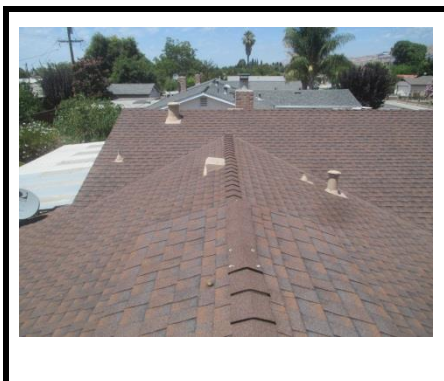
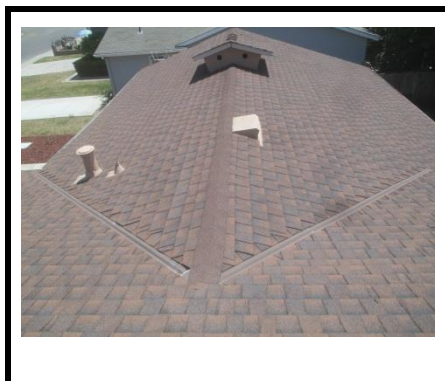
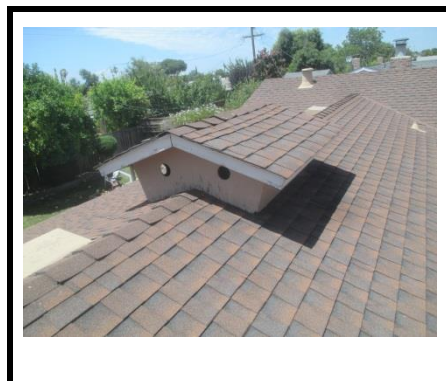
Pictures 1 thru 3... The asphalt composition roof covering was in acceptable condition, the pop up top is decorative only.

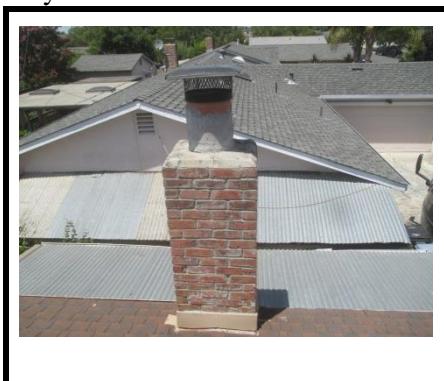
Picture 1... The brick chimney appeared to be stable when pushed on and in acceptable condition.

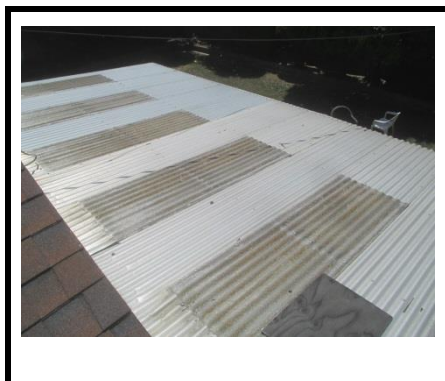
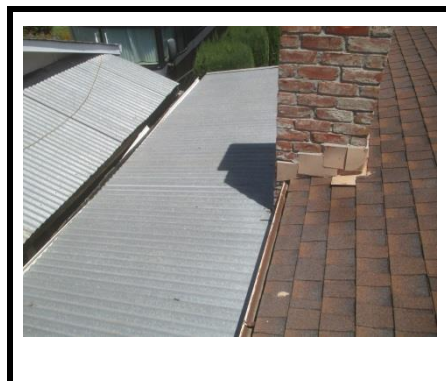
Pictures 2 & 3... The roof covering over the patio area and right side storage shed were in acceptable condition.

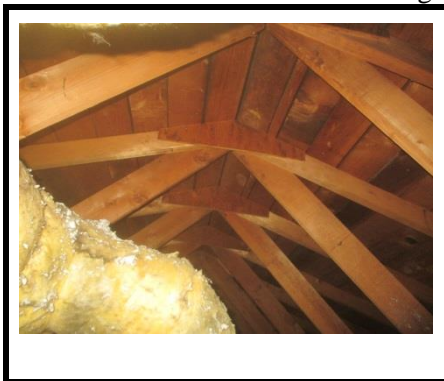
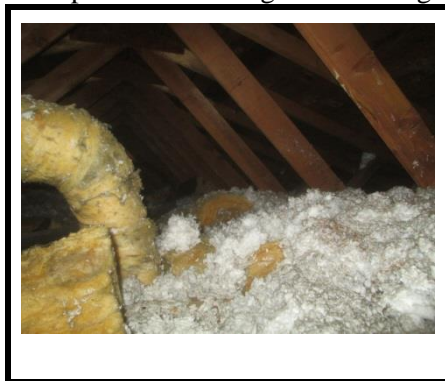
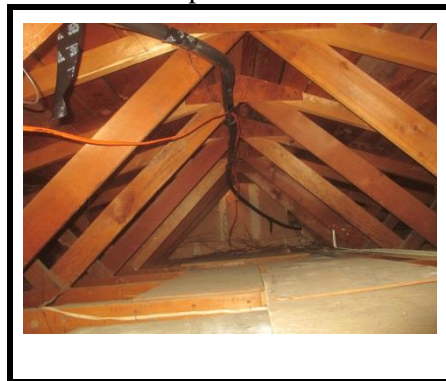
Pictures 1 thru 3... The attic area and roof framing were in acceptable condition and well insulated. The attic area in the garage was in acceptable condition however the firewall between the garage and the house was open in one area, sealing up the firewall is recommended.

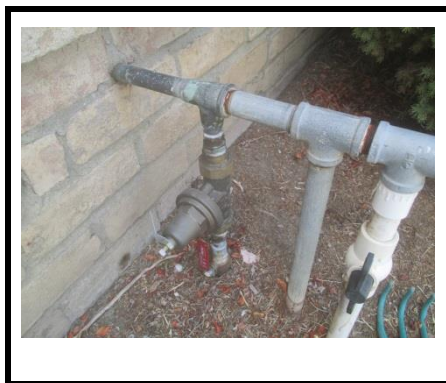
Picture 1... The main water shut off valve is located at the front of the house and in acceptable condition.

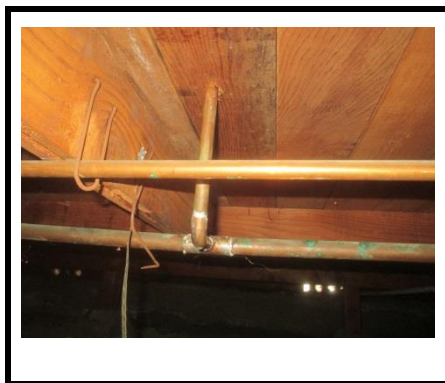
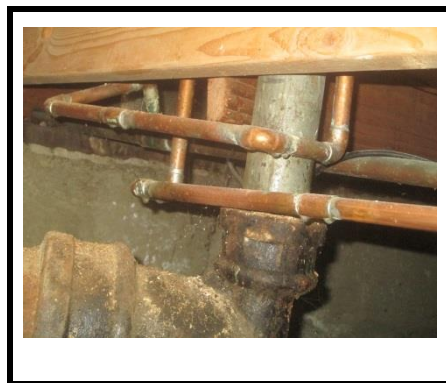
Pictures 2 & 3... The visible copper water supply piping was in acceptable condition with no leaks or damage observed.

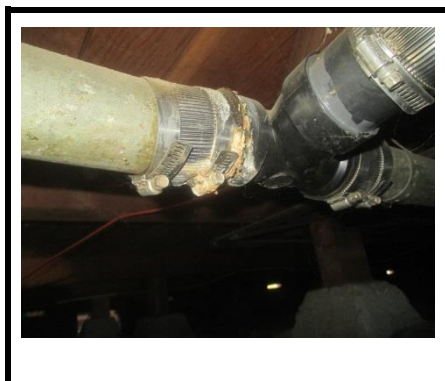
Picture 1... The ABS plastic drain piping and galvanized steel drain piping rubber connection fitting under the kitchen area showed signs of past leaks, although no current leaks observed the fitting should be monitored and the band straps tightened up periodically if necessary.

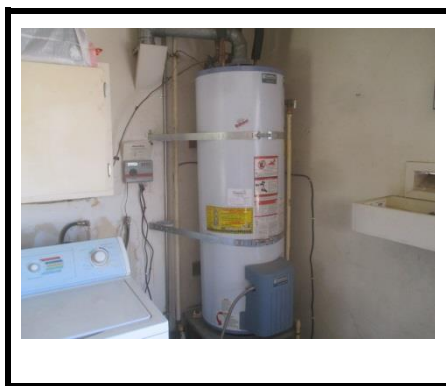
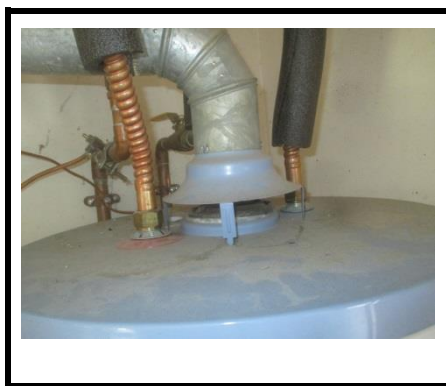
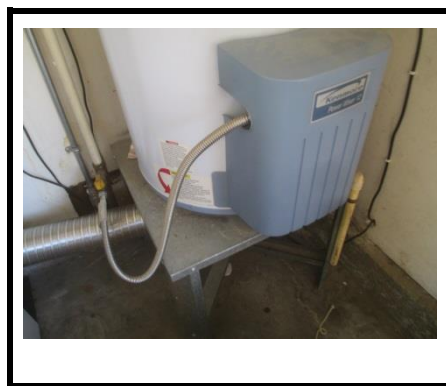
Pictures 1 thru 3... The water heater was in acceptable working condition with no leaks or damage observed.

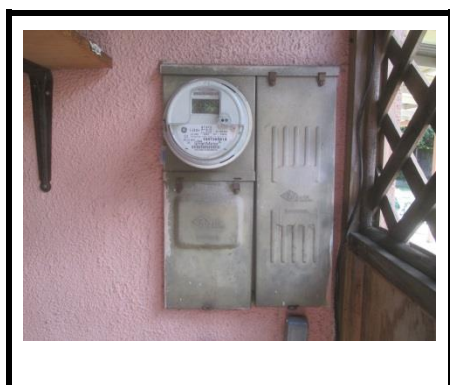
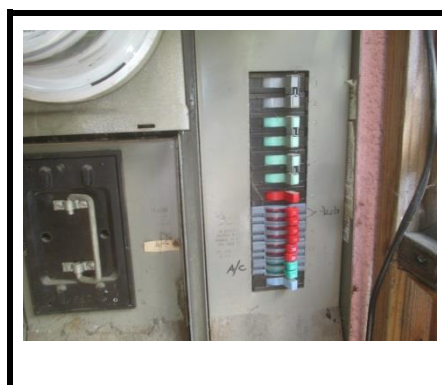
6. Circuitry in the main service panel was not labeled. Each circuit should be identified, allowing individuals unfamiliar with the equipment to properly operate it, if necessary. When the opportunity arises, we recommend accurately labeling the circuits by actually operating the breakers.
7. The main distribution panel in this dwelling was a brand called Zinsco. Zinsco panels and circuit breakers have not been manufactured for some time. Of greater concern is the fact that some Zinsco circuit breakers have failed to trip at their rated amperage. As an upgrade, we recommend serious consideration be given to replacing any Zinsco panels in the electrical system. In addition, if significant remodeling is anticipated, the panel(s) will, most likely, have to be replaced.

Pictures 1 & 2... The old 100 amp Zinsco panel was in acceptable condition however the circuits were not labeled, labeling the circuits is recommended, this old Zinsco panel should be replaced if any remodeling is performed

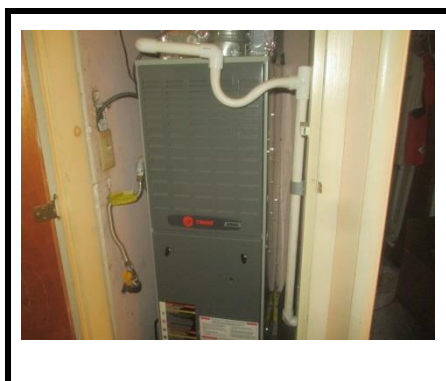
Picture 1... The gas fired forced air heating system was in acceptable working condition.

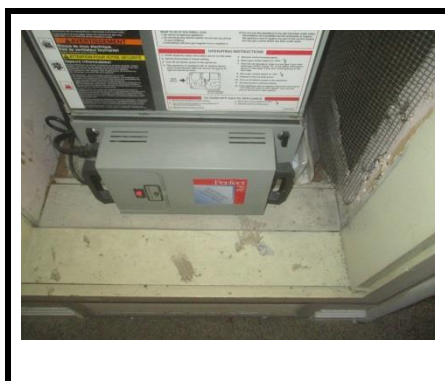
Picture 2... The electronic air filter was in working condition.

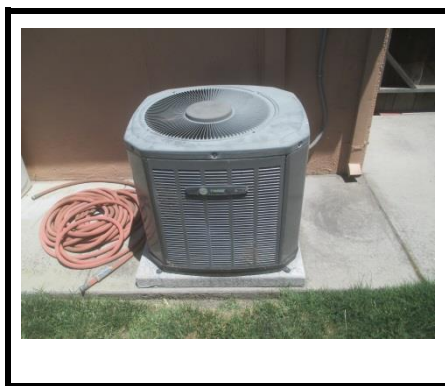
Picture 1... The A/C condenser was in acceptable working condition.

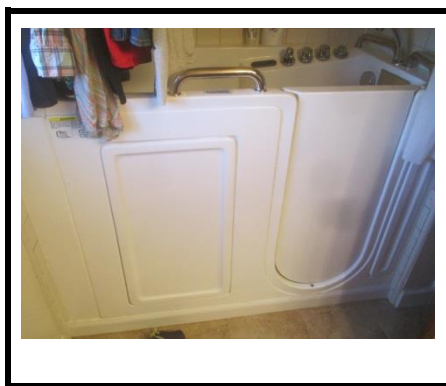
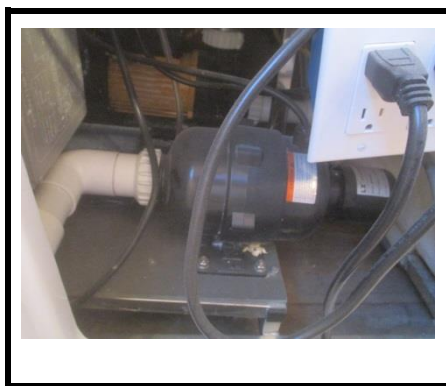
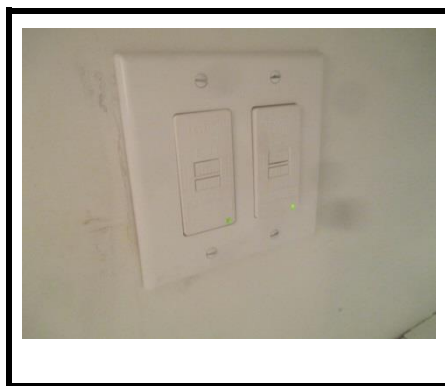
Pictures 1 thru 3... The hall bath walk in jetted tub was operated and in acceptable working condition, the motor compartment was in acceptable condition with no signs of leaks, the GFCI protection resets are located in the hall bath closet.

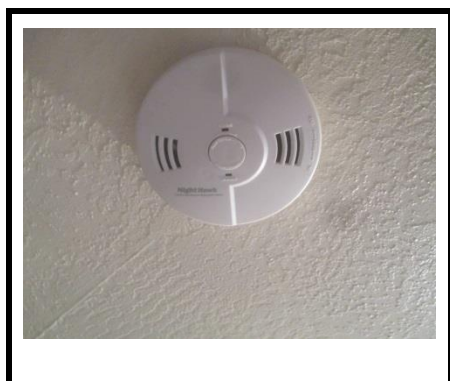
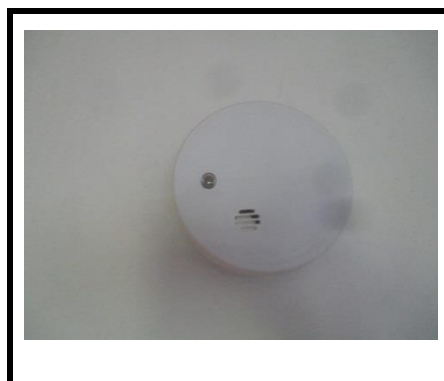
Pictures 1 & 2... The carbon monoxide and smoke detectors did respond when the test buttons were pushed.
